**BAKER FLOODWATER RESERVOIR  
SITE 2**

**NH 00231**

**PHASE I INSPECTION REPORT  
NATIONAL DAM INSPECTION PROGRAM**

JUNE 1979

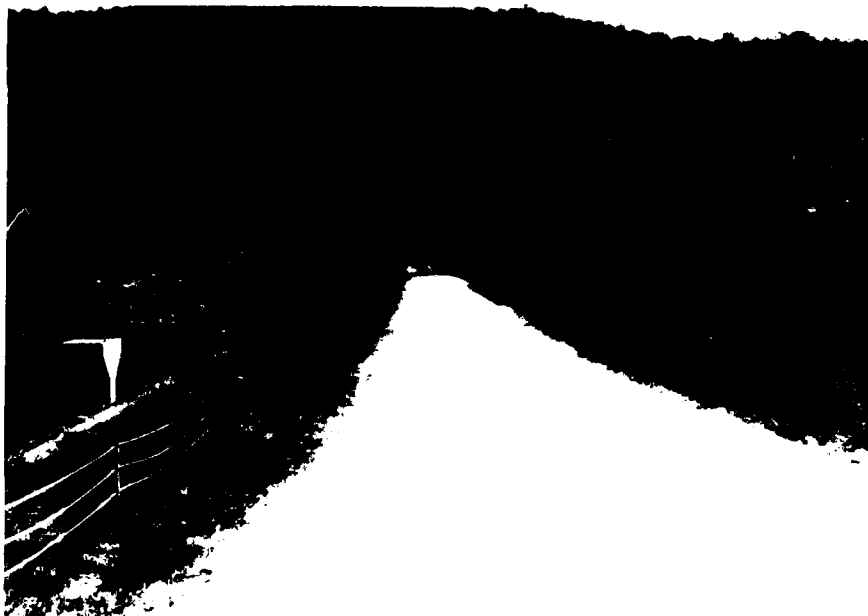
The crest of the dam is 20 feet wide and has a sand and gravel roadway, in good condition. Photo No. 5 shows the crest. No significant misalignment of the crest was observed.

PHOTO NO. 5 - View from right abutment of dam  
crest and roadway.

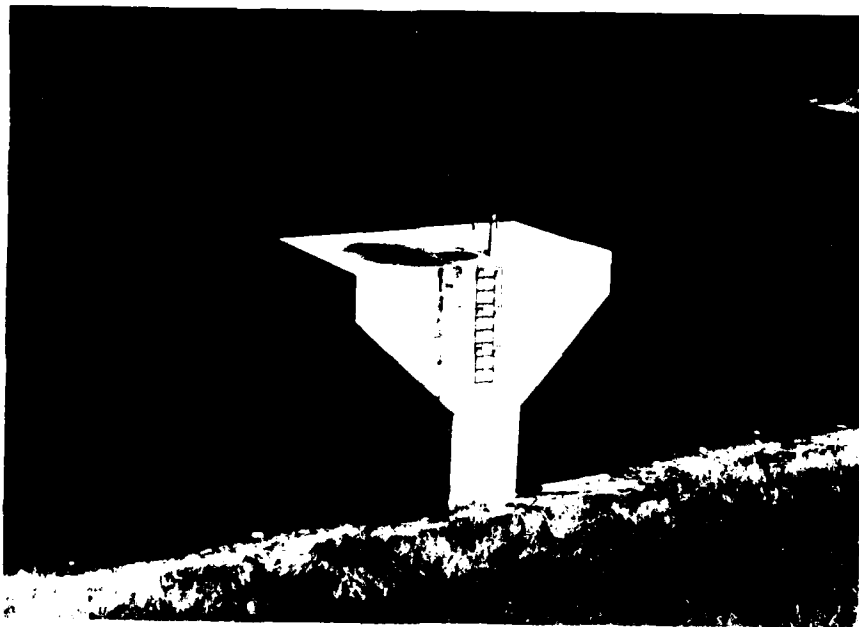
c. Appurtenant Structures. Visual inspection of the concrete riser (principal spillway) structure, emergency earth spillway outlet works structure did not reveal any evidence of stability problems. The riser structure generally appeared to be in good condition, except for rust staining, heavy scaling and loss of surface mortar in some locations on the shaft walls.

The concrete riser (principal spillway) structure consists of three elements; an overflow control with low stage inlet and high stage, covered top crest spillway, a vertical transition and a closed discharge conduit with an impact type stilling basin. The riser structure is placed in the embankment. Visual inspection revealed that the riser structure appeared to be in good condition, except for rust staining, extensive surface scaling, cracks and loss of surface mortar in some locations. Loss of coarse aggregate particales were noted, Photos No. 8,9,10,11 & 12.

PHOTO NO. 8 - View of riser and covered high stage inlet  
from dam.

- (a) Repair the concrete surface of the riser structure.
- (b) Repair the concrete spalling at the end of the 4 foot diameter discharge pipe.
- (c) Observe and record the condition of the spring on the right abutment with changing reservoir level. It is particularly important that these observations be made during the next filling of the reservoir.

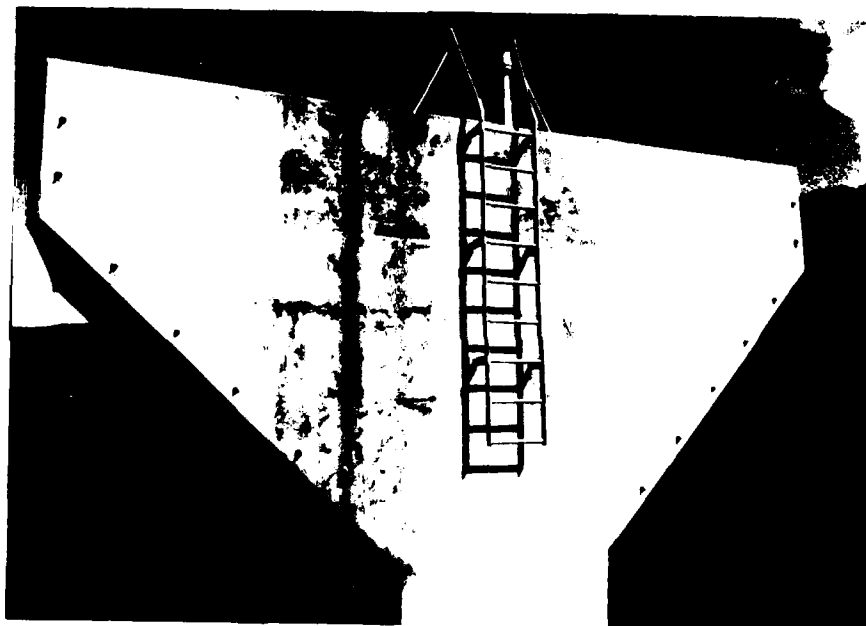
PHOTO NO. 9 - View covered high stage inlet.

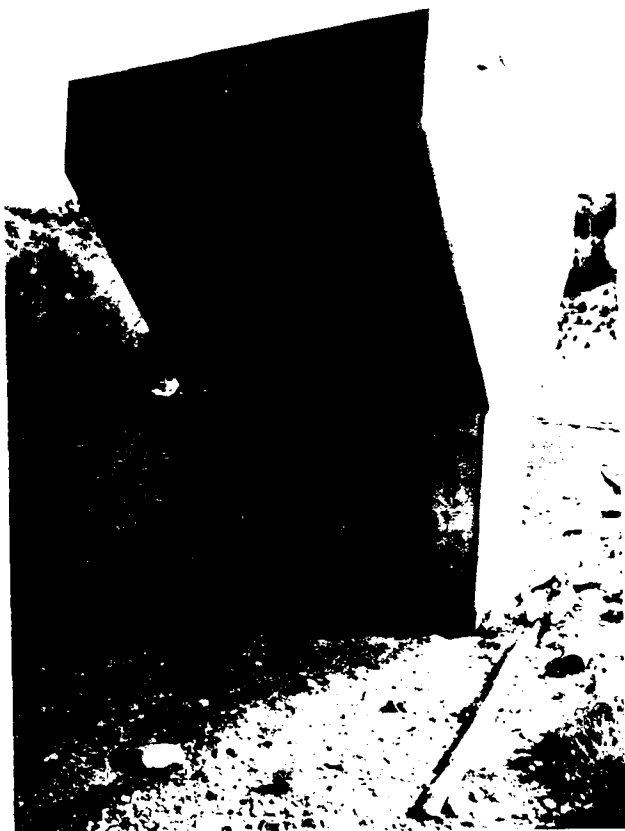
PHOTO NO. 10 - View of right  
side of riser and high  
stage trash rack.

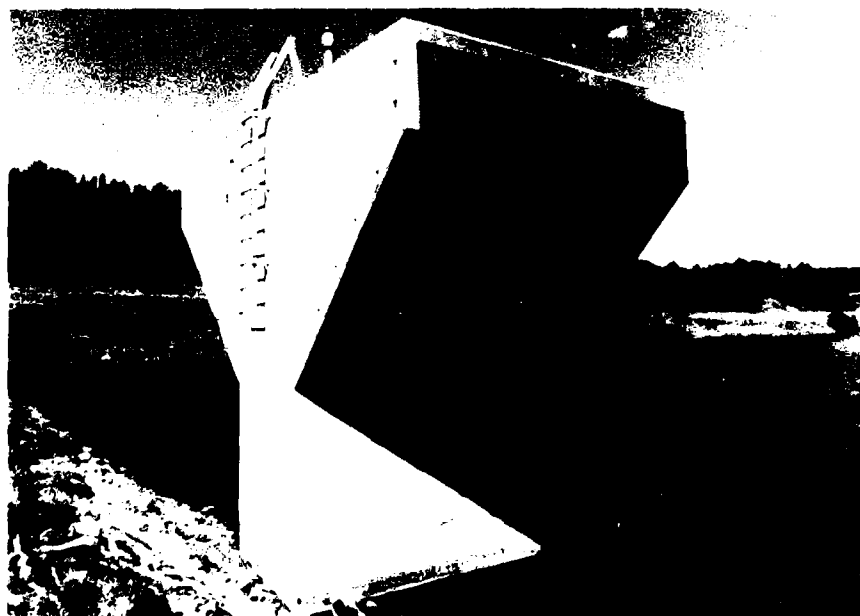
PHOTO NO. 11 - View of left side of riser and high  
stage trash rack.

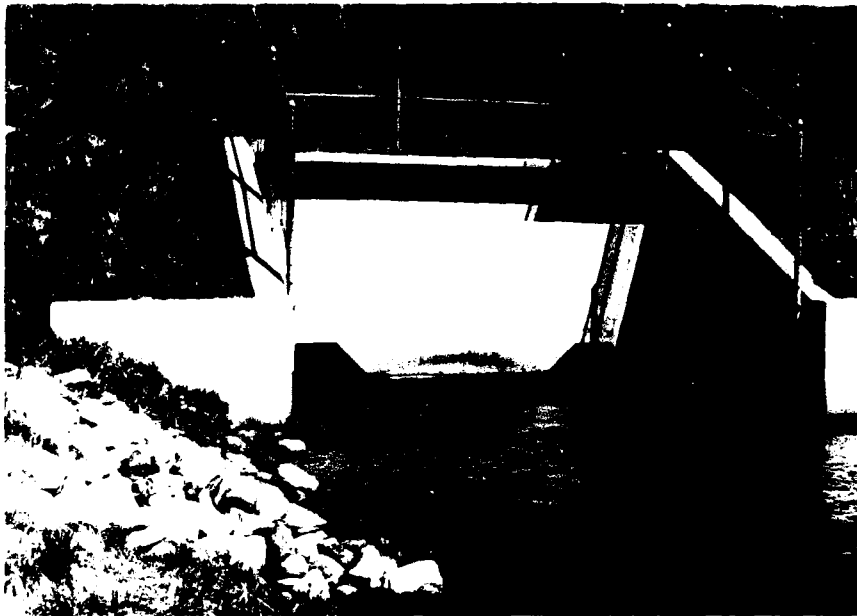
The outlet works structure at the toe of the dam consisting of 48 inch reinforced concrete pipe and stilling basin structure is located at the original stream channel, Photos No. 13 & 14. The apron slab and training walls of the stilling basin structure appear to be in sound condition. Some water staining and concrete spalling were noted at the discharge pipe area.

PHOTO NO. 14 - View of impact type stilling basin.

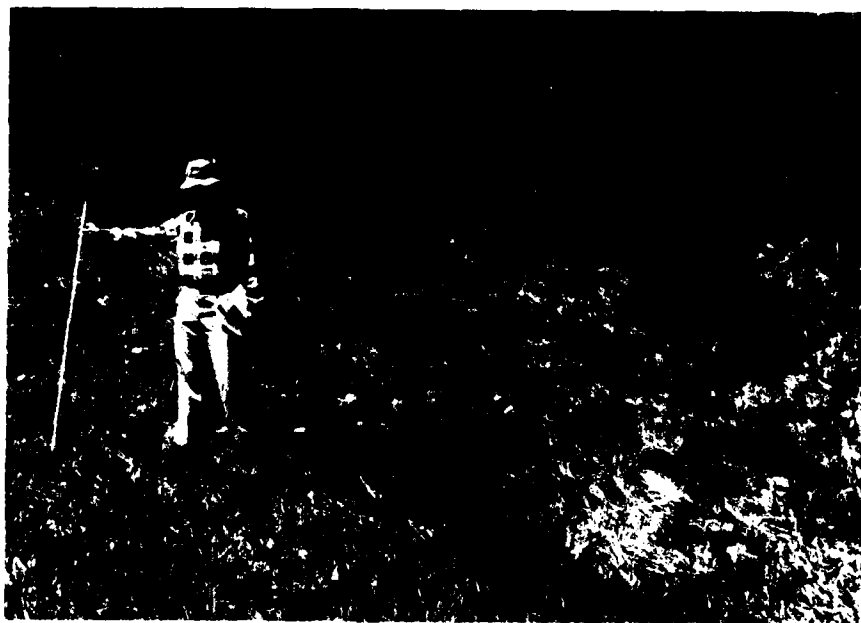
There is a wet area at the toe of the slope which appears to be due to runoff from a spring on the right abutment about 10 feet from the toe of the embankment at about El 832. The area of this spring is shown in Photo No. 17. The pool elevation at the time of inspection was about 834.5. Since the dam is about 160 feet wide at El 834, it does not seem likely that the spring is a result of seepage through the embankment. This spring and the wet area at the toe of the slope should be closely observed at various reservoir elevations to establish if flow from the spring is related to the reservoir elevation.

PHOTO NO. 17 - Seep area at approximately elevation 832 on downstream side of right abutment.
